Beirut Municipality Rapid Building-level Damage Assessment Municipality of Beirut and UN-Habitat October 2020 Working Version

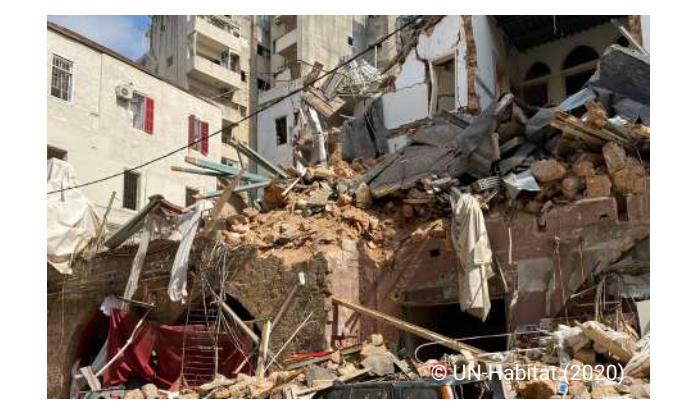
Total collapse⁶ Buildings that had experienced total structural failure.

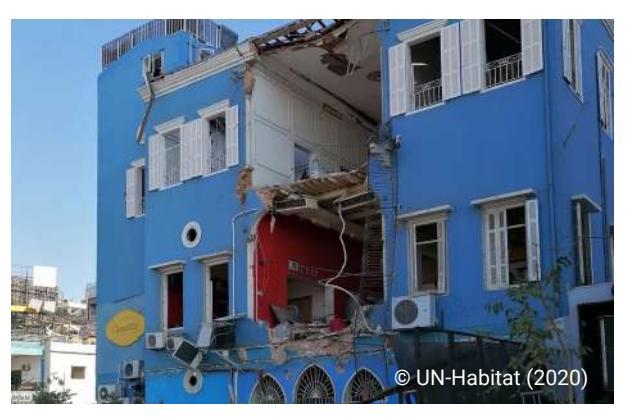
Unsafe / evacuate Buildings that are structurally unsound and require evacuation.

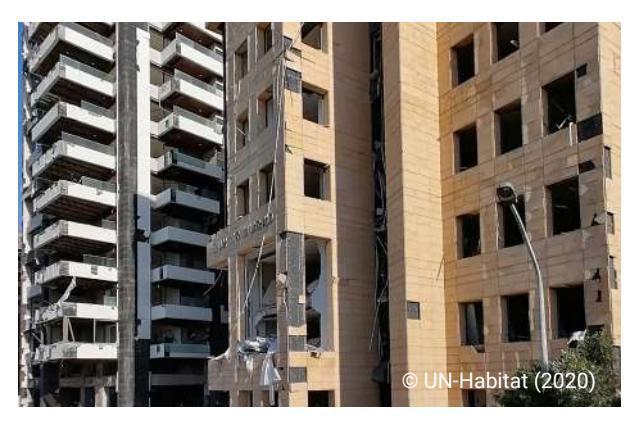
Restricted use

Buildings that were subjected to considerable damages in their architectural components (falling architectural elements that might affect public safety).

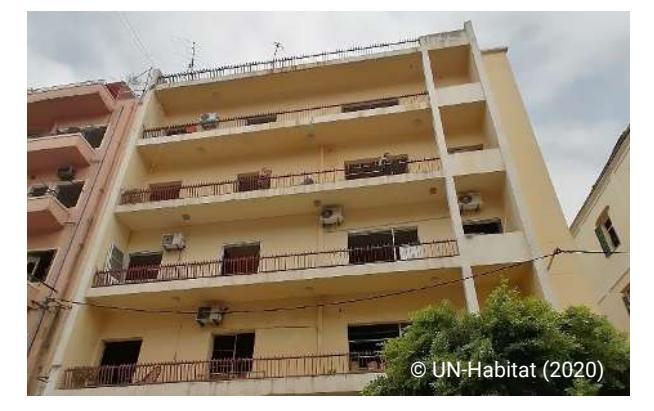
Safe / minor damage

Buildings that were subjected to minor defects, such as broken glass. Buildings that were not affected at all also fall under this category.

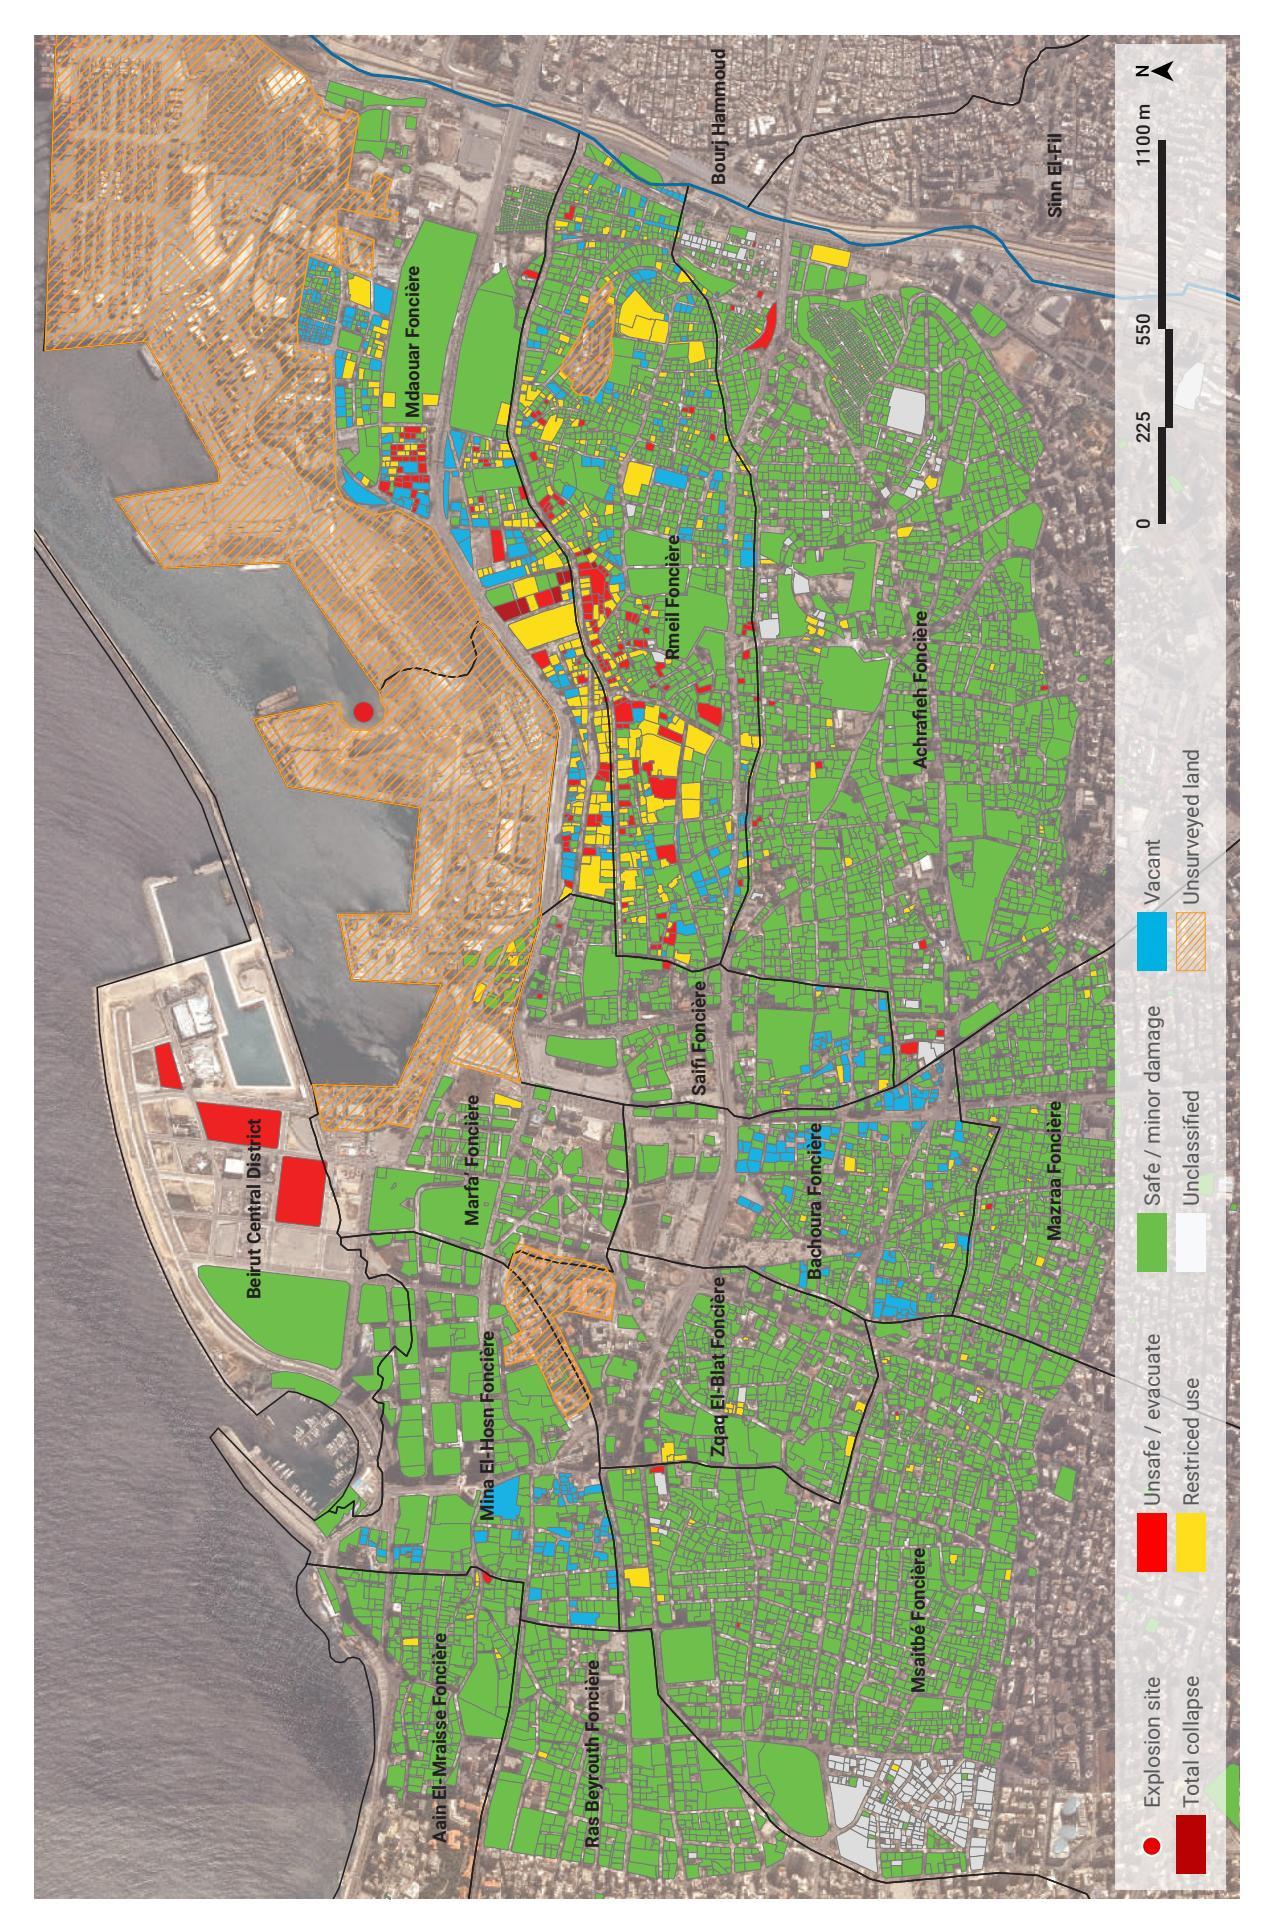
Figure 6 Detailed map showing damage categories of assessed plots as at 5 September 2020.
