LEAKAGE REDUCTION PROJECTS UNDERTAKEN BY RAND WATER

WATER RESOURCE
PLANNING AND
CONSERVATION

August 2002

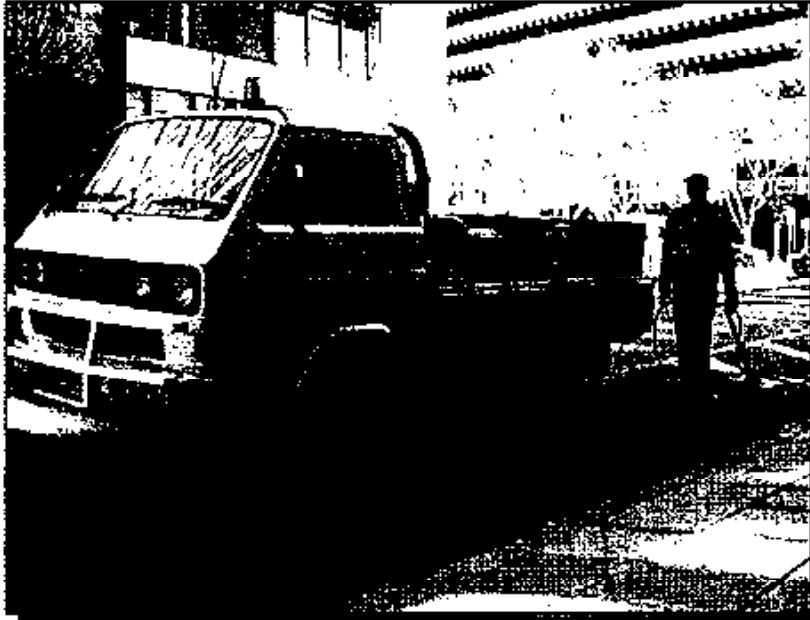
Figure 2-8 Ground Penetrating Radar (Courtesy RVM Surveys)

progress. The data can be recorded on tape for further analysis and record purposes. Water in the ground is particularly reflective to radar, which thus enables radar to be used to locate water in the ground. Further investigative work is required to determine whether the water is ground water or leakage from pipelines.

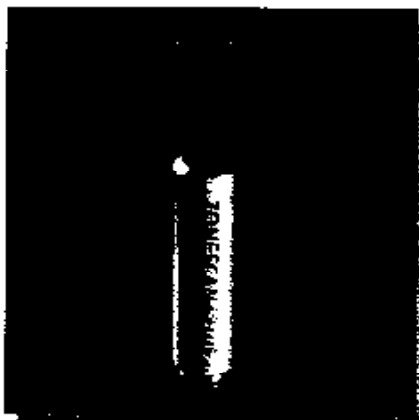
Figure 2-10 Zonescan (Courtesy Gullerian International, Switzerland)

In this technique programmed logger units are deployed in a designated area. The units log leak noises for a pre-determined period and are then removed and downloaded into application specific software. The Zonescan (Figure 2-10) or Aqualog (Figure 2-11) system is not used for pinpointing leaks, but rather for the localisation of leak noises. This requires follow-up with a more accurate technique like the Leak Noise Correlator.

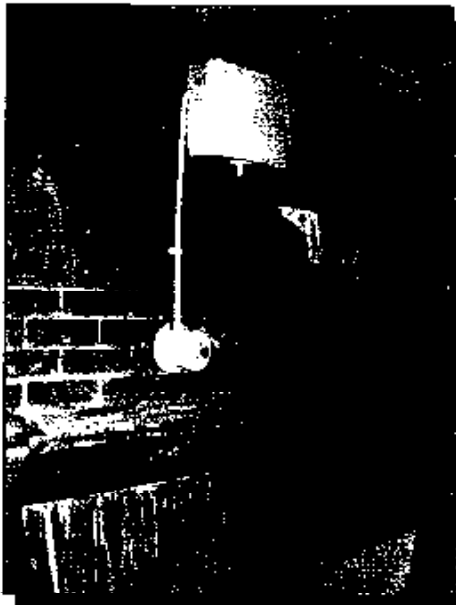
Figure 3-4 Installation of a new push button urinal (Courtesy Ayanda Consulting)

- Correction of all problems regarding poor or incorrect installation of plumbing fittings by the original contractors (**Figures 3-3 and 3-4**);
- Fixing water leaks;
- Providing on site training to the users of the water saving devices.

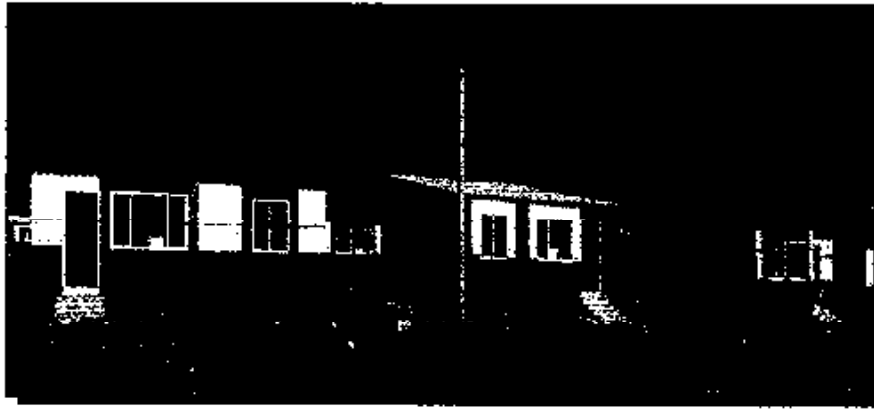
Figure 3-16 The houses were designed to optimise the use of sunlight. (Courtesy W le Roux & Assoc.)

The houses were designed to optimise the use of sunlight (**Figure 3-16**). The biggest facades and windows faced North, aiming to ensure the houses remain cool in summer while retaining heat in winter. This reduces the internal heating requirements of the house which can account for approximately a third of the household's electricity costs in winter.

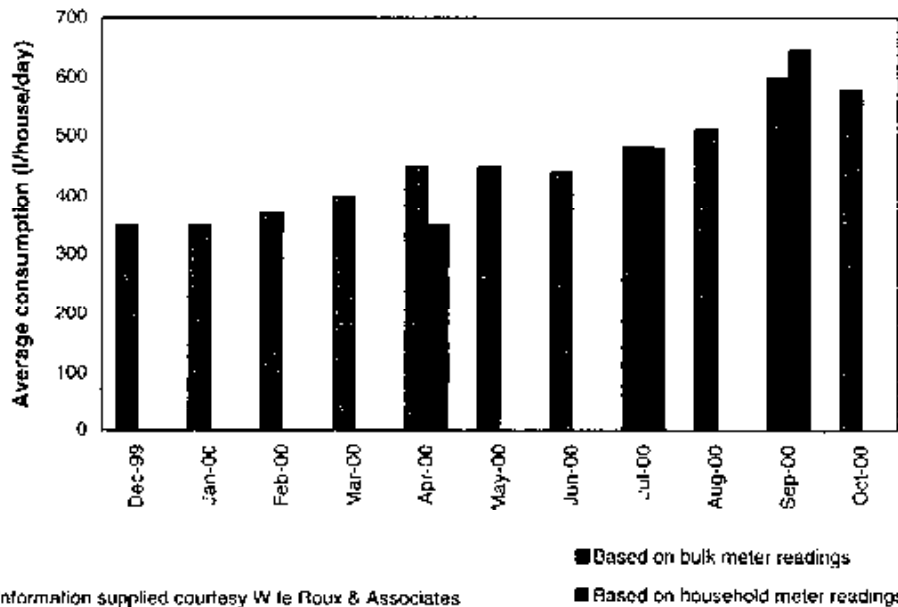
Figure 3-18 Monthly water consumption in the All-Africa Games Village

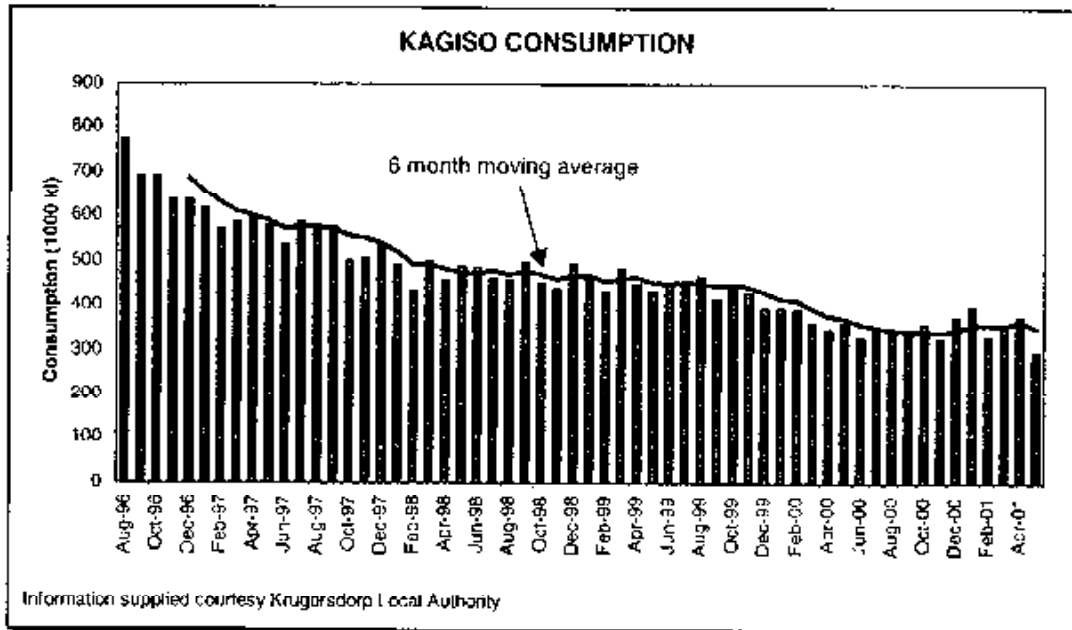
Figure 3-30 Monthly Consumption for Kagiso

The evaluation of monthly water consumption indicates that the retrofit project has contributed to a continued reduction in consumption. It is not possible to determine with accuracy how much of the savings is attributable to the project due to numerous other activities that have resulted in savings. The results do suggest that the retrofit project has had a significant impact on the overall system demand.

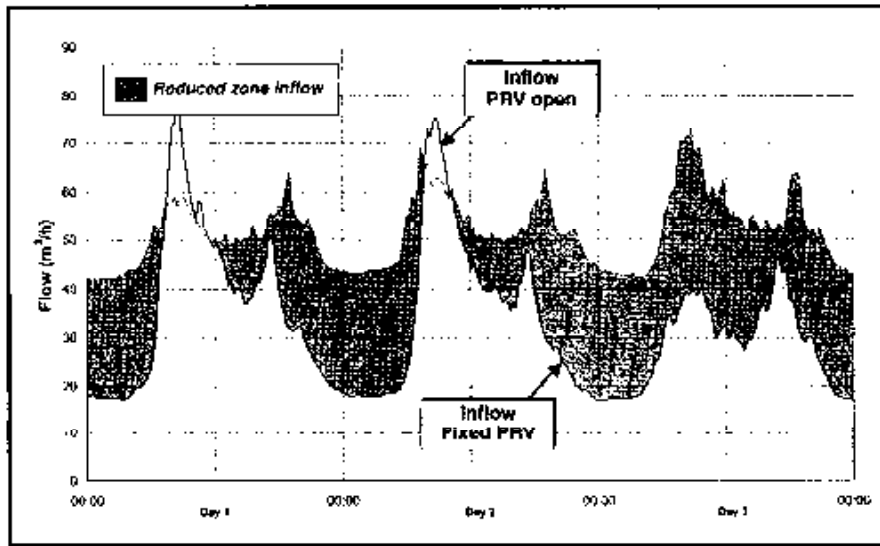
Figure 4-4 Reduced zone inflow using a Fixed Outlet PRV.
