PHYSICAL DAMAGE ASSESSMENT OF PRIVATE SCHOOLS

IN RESPONSE TO THE BEIRUT PORT
EXPLOSIONS

October 2020

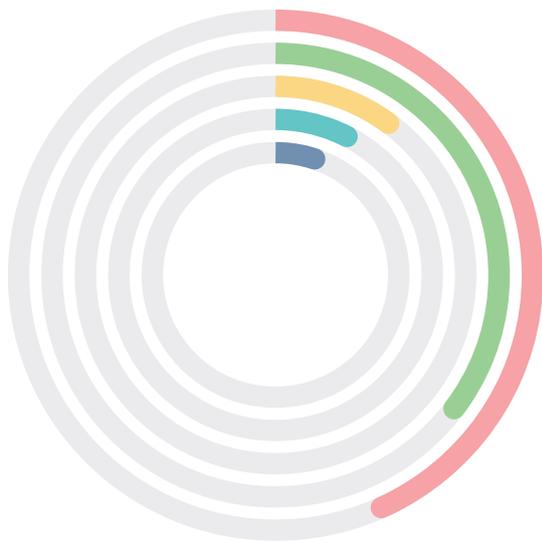
Figure 2 Status of rehabilitation of the 113 schools at the time of assessment

- 43%** Rehabilitation started / completed
- 35%** Assessment completed by UN-Habitat and Frontline Engineers volunteers
- 10%** Assessment completed by the school
- 7%** School did not answer
- 5%** School was not affected

From a total of 113 assessed schools: 6 schools were found to have sustained no damages (not affected); 9 schools were not available/accessible for the assessment exercise (no answer); 98 schools sustained varying levels of damage, out of which 48 had started or completed rehabilitation (rehabilitation started/completed); 11 had completed a damage assessment and produced a detailed BoQ on their own (assessment

completed by school); and 39 were assessed through this exercise with new BoQs produced (assessment completed by volunteers).

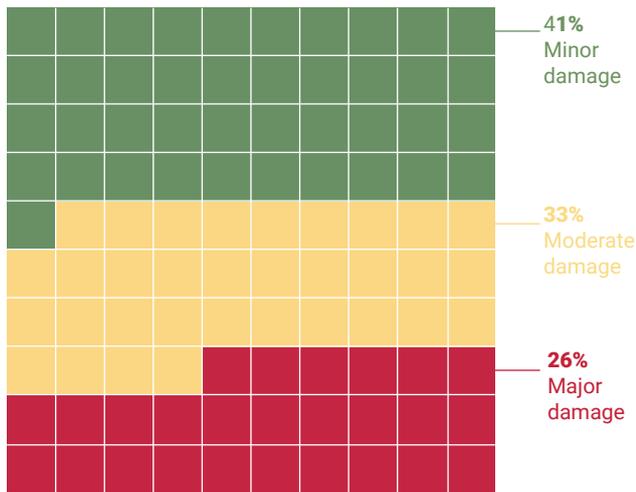
Figure 4 The level of damages sustained by the 50 schools still identified in need of rehabilitation at the time of assessment

The 50 schools that need rehabilitation incurred various levels of damages: 19 have minor damage, 19 moderate damage and 12 major damage.

Out of 50 schools still in need of rehabilitation, 12 schools were classified as severely damaged, 19 schools were moderately damaged and 19 suffered minor damages. The combined estimated repair costs of these 50 schools is nearly USD 2,500,000. Out of the 50 schools, 17 are considered to be highly vulnerable¹ and have a total estimated rehabilitation cost of around USD 600,000.

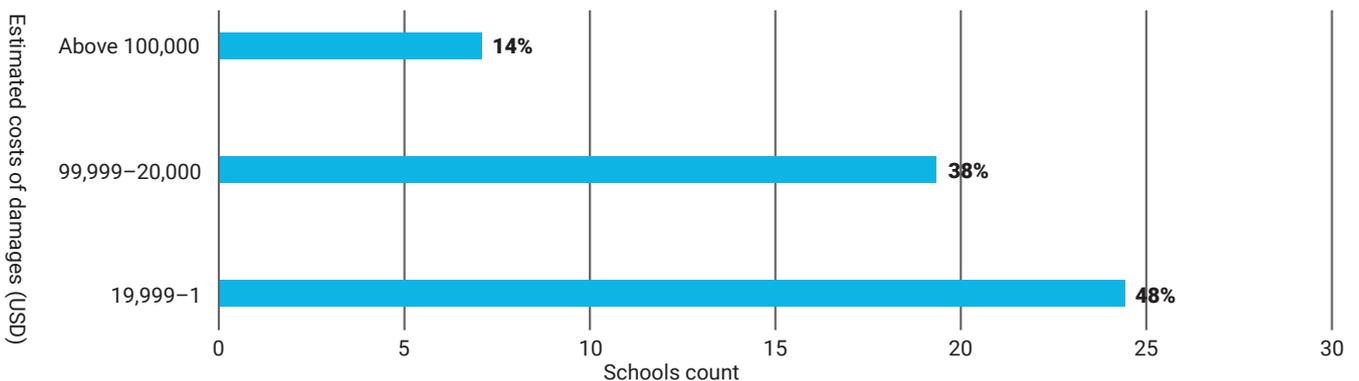
Figure 6 Estimated costs of damage incurred by the 50 schools in need of rehabilitation

Classified according to the estimated cost of repairs, 24 school have incurred damages estimated at lower than USD 20,000 per school, 19 schools have incurred damages estimated between USD 20,000

and 100,000 per school and 7 have incurred damages estimated above USD 100,000, with College des Freres in Gemmayze sustained the most damages at an estimated cost of USD 675,000.

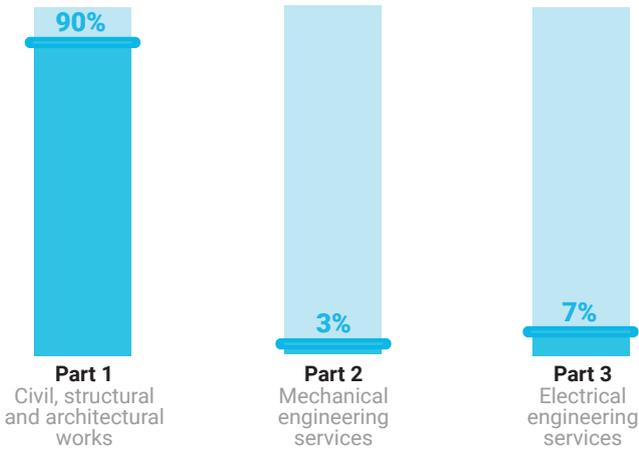
Figure 7 Percentage of types of damages incurred across the 39 assessed schools

The most recurrent type of damage observed was civil, structural and architectural at 90 per cent, with electrical engineering services and mechanical damages at 7.16 per cent and 2.66 per cent respectively.

The BoQ was divided into three parts:

- Part 1 – Civil, Structural & Architectural works
- Part 2 – Mechanical engineering services
- Part 3 – Electrical engineering services
